**REPORT NUMBER: 17090901080 : DATE: 01/17/2012**

## **Home Inspection & Energy Efficiency**

FULL REPORT FOR: XXX

ON: 17th January 2012 - **FEE \$499.00**

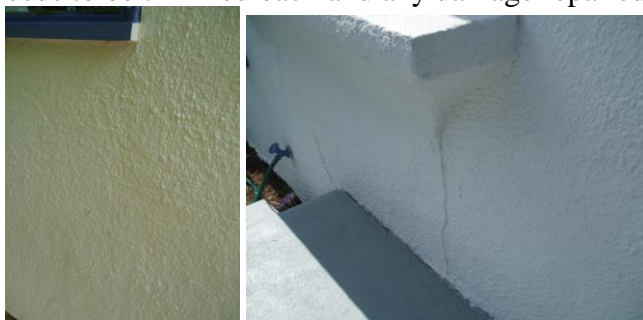
- 1) The exterior "Stucco" finish looks to have been repaired in recent times and seems in an appropriate condition but during the forthcoming winter months inspections and any repairs are recommended. Old cracking where movement in the house has occurred around windows and the like have been sealed over and should be closely monitored. Shrubbery up against the home needs to be trimmed back and any damage repaired.

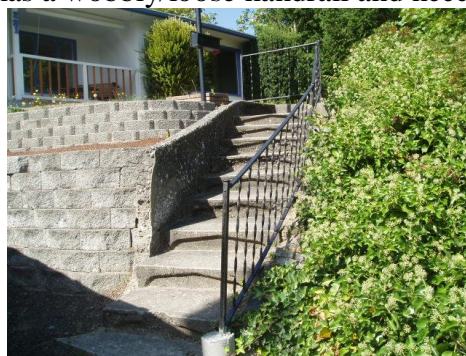
- 2) The retaining walls around the garage have moved and cracked and some repairs may be warranted.
- 3) The path ways have cracked and heaved and may want some repair.
- 4) The front yard stair has a wobbly/loose handrail and needs to be fixed more appropriately.

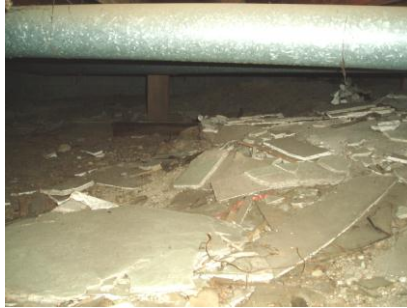
- 5) The living room extension has a crawlspace under it, with out any access, though two air vents are present and a photo was taken of the inside. Recommend breaking open one of these vents and creating an access point for appropriate inspection/repairs etc. Debris was noted on the crawlspace floor and heating vents are un-insulated.

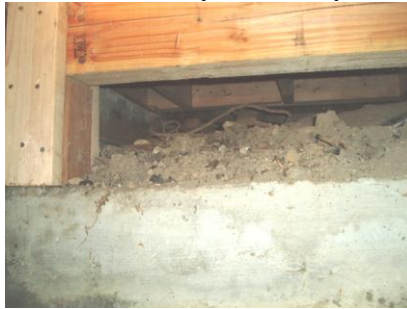
- 6) The kitchen floor and sub structure has been replaced and full access under part of it is not possible. No insulation is present either. This area will need to be monitored for rain water entry in the wet winter months with any necessary remedies if appropriate.

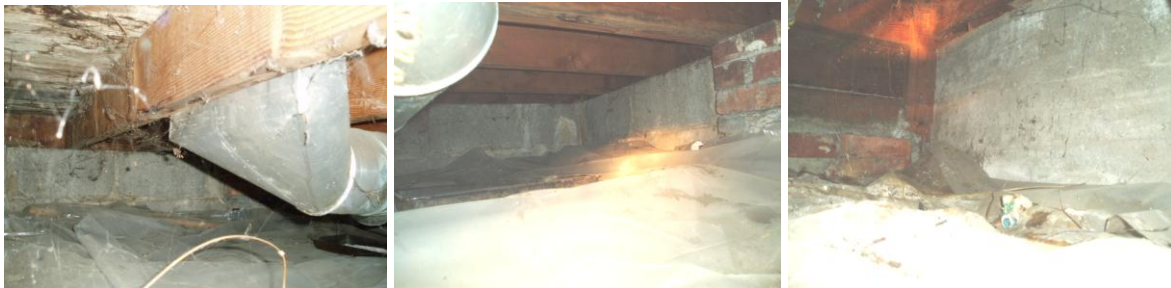
- 7) The crawlspace under the bathroom area is also extremely tight and earth to wood contact is present in a siding skirt and therefore hidden insect activity and or rot may be present. These timbers seem to have been there from construction many years ago.

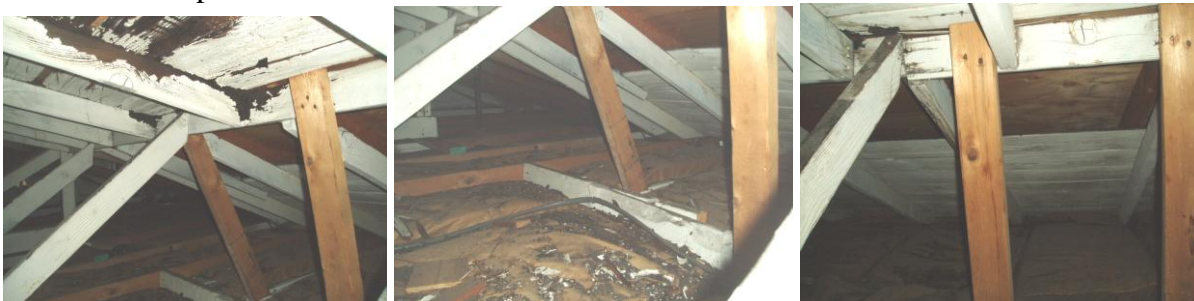
- 8) In the attic area over the third bedroom/kitchen, old fire damaged timbers are present. Repairs have been carried out with a newer kitchen ceiling. Access into the area was deemed unsafe. Some old structural timbers look still to be in need of repair/replacement. No access into the main bedroom ceiling was found! Recommend further evaluation and repair.

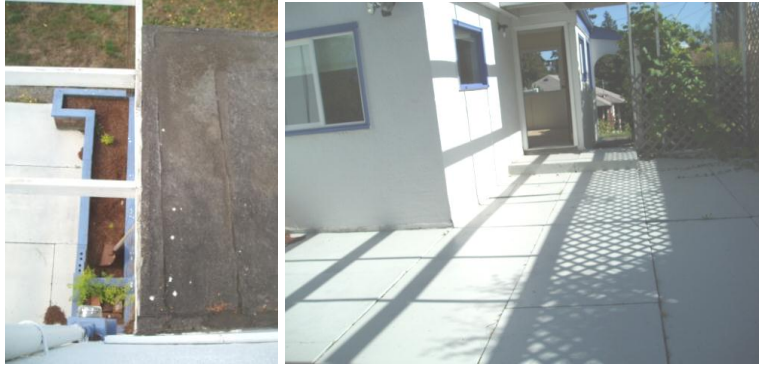
- 9) Some past water entry into the basement seems to have occurred around the south west end as staining around cracks in the concrete and old plumbing protrusions are present.

- 10) One or two beetle exit holes were noted in the basement timbers, which confirms high moisture levels and therefore some hidden damage may be present.
- 11) The rear yard patio may well pool water which could seep down into the basement and its slope may want to be altered especially if drainage is poor. The sloping bathroom roof here is also an issue as no gutter is provided. A trellis structure is present and timbers are attached to the wall and the propensity for rot and water entry behind the wall are great and repairs are recommended. Hidden damage may be present.

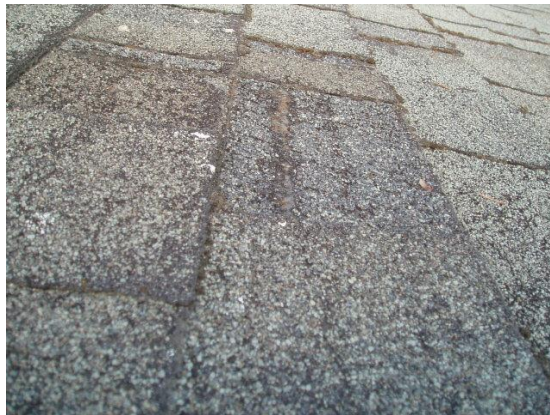
- 12) The roofing material is damaged in many places due to pressure washing and repairs are necessary to ensure against leakage. Recommend that a professional roofer inspect/repair issue a 5 year roof warranty or replace as necessary.

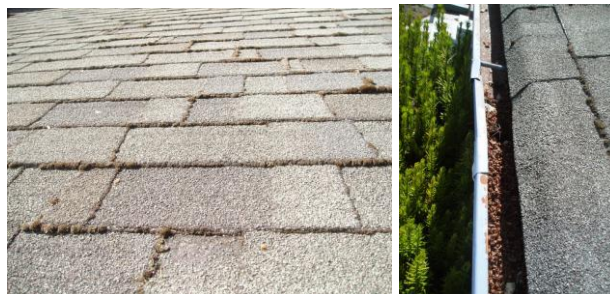
- 13) Moss is prevalent and will need to be attended to. Gutters also need cleaning/repairs in places.

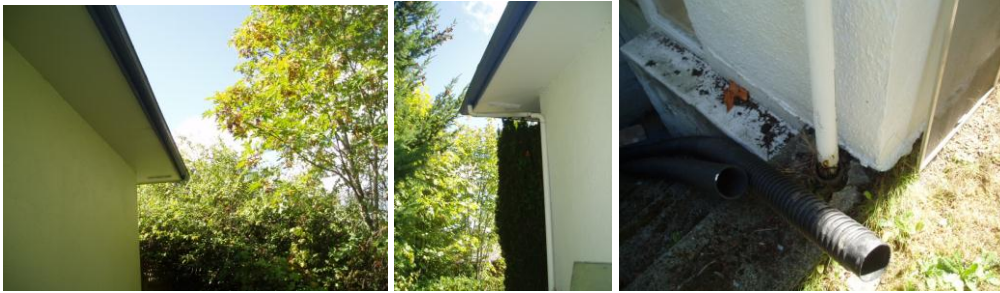
- 14) As mentioned gutters are missing in places (rear bathroom sloping roof) and down spouts are un-attached/fallen off and or have rusting holes all need to be attended to asap.

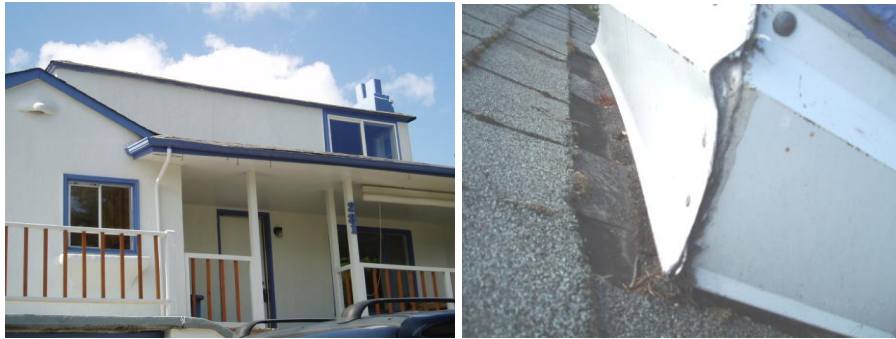
- 15) The chimneys have no rain caps or a cricket to fend of rain and therefore rain water entry around and inside could occur. The upper section of the roof was not traversed only viewed from the lower roof.

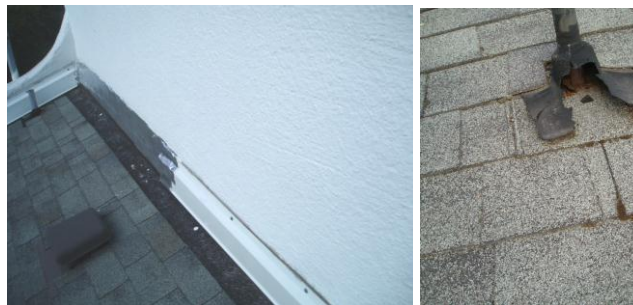
- 16) Metal flashing along one section has been replaced with some aluminium stick down membrane. At least one plumbing boot has rotted out and needs replacement.

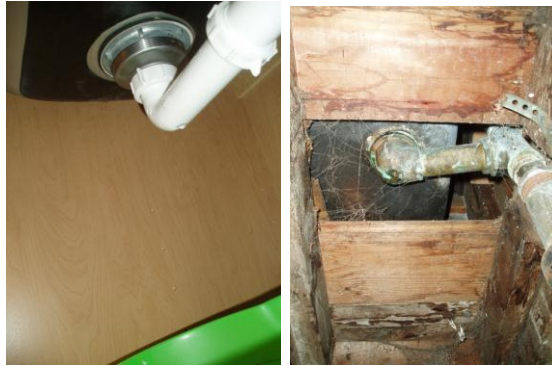
- 17) Leakage was noted from the left hand kitchen sink waste pipe and also the bath tub drain seal which require repair.

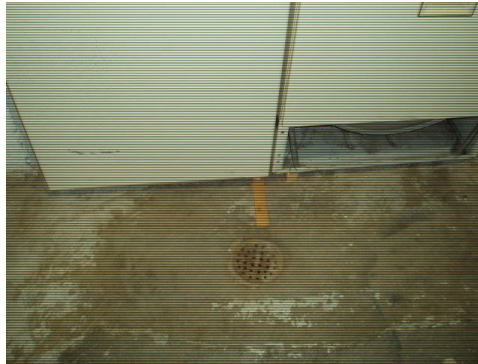
- 18) The toilet flush handle and flapper were noted to stick and require some attention. The toilet anchors are a loose and some exposed sub floor is present which require repair.
- 19) Recommend checking and testing the floor drains as appropriate. Including the one around the basement back door area.

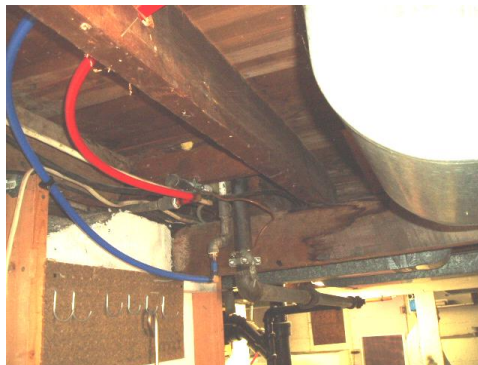
- 20) Water flow was noted to be poor in places and the kitchen sink aerator had debris in it that had to be cleaned out. Old galvanised pipes still in use probably want replacement!

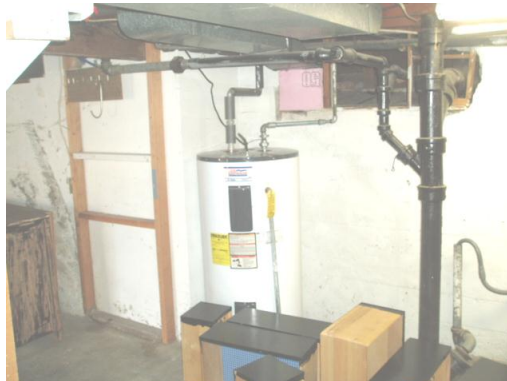
- 21) The hot water heater is 10 years old and may require replacement at any time. The electrical supply cable should be sheathed in a conduit.

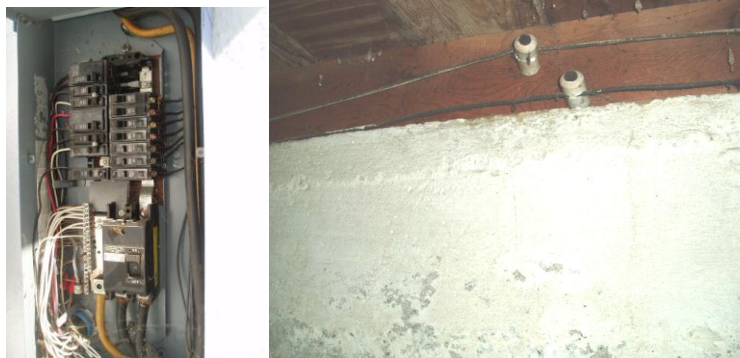
- 22) Some outlets are grounded three pin but some are not. The home also has two pin and energised “Knob & Tube” wiring. Exposed splices of the former were noted. Recommend that an electrician evaluate and repair/replace and certify safety of circuits as appropriate.

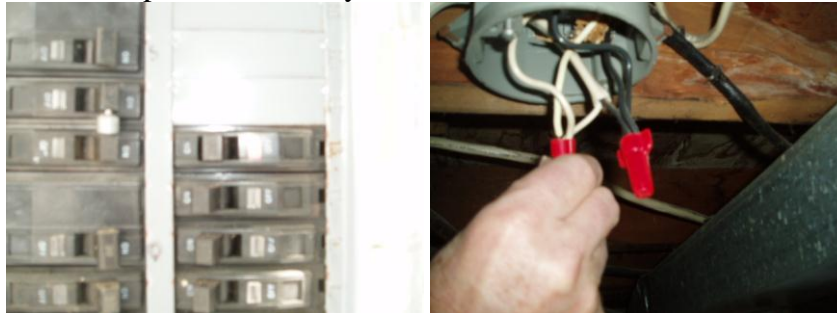
- 23) An electrical fault was found on the bathroom circuit where the GFCI and light tripped a 20 amp breaker. A loose neutral junction was noted in the basement. Recommend appropriate evaluation and repair as necessary.

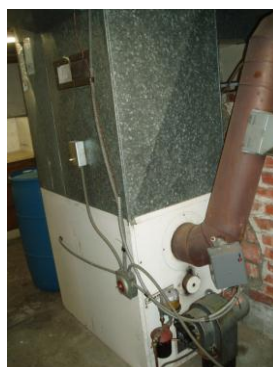
- 24) This system was not functional in the heating mode at the time of the inspection but the air handling did operate. Recommend that the system be fully commissioned/serviced/repared as necessary.

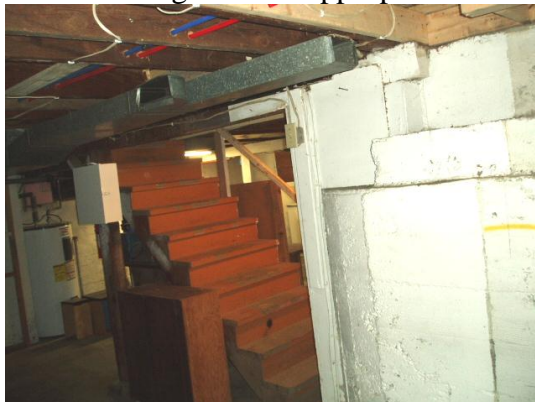
- 25) The kitchen is not provided with any source of heat though past ducts are near by and are left open. Recommend installing vents as appropriate.

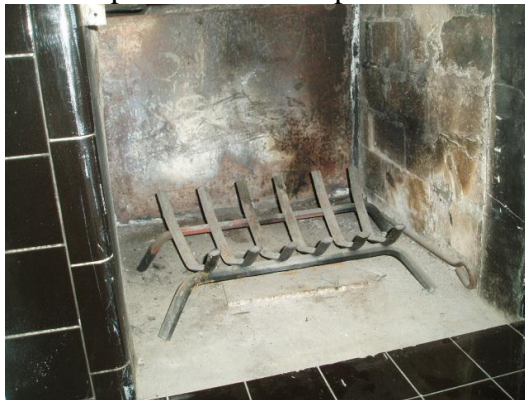
- 26) The fireplace should be inspected/cleaned/repaired and certified prior to any usage.
