**REPORT NUMBER: 07100901093 : DATE: 01/07/2012**

## Home Inspection

SUMMARY REPORT FOR:

**ON: 7th January 2012 - FEE PAID \$349.00**

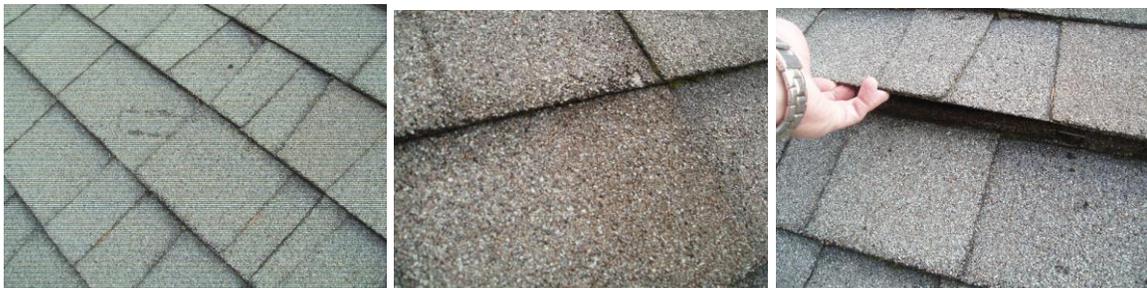
- 1) The roof is a 30 year style architectural asphalt shingle. Unfortunately it as been pressure washed in the past and some minor damage has been caused as can be seen from wand marks in the material piercing through the top layer. Also some shingles have come unglued and therefore some bitumastic application may be beneficial for both items.

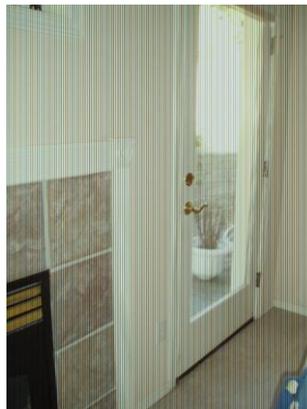
- 2) The rear single door off the living room is not hung correctly and scraps along the threshold and needs some adjustment. Recommend appropriate evaluation and repair as necessary.

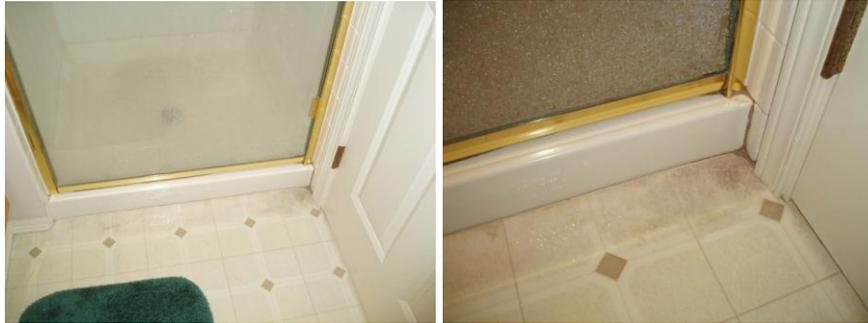
- 3) The hall bathroom shower door/frame has been letting water by and dripping onto the vinyl and into the sub floor and some minor damage is present. Recommend appropriate repairs as necessary.

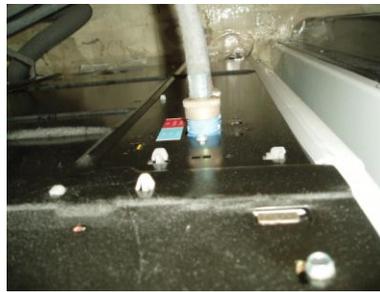
- 4) The washing machine has badly gouged the vinyl floor and needs repair or replacement.

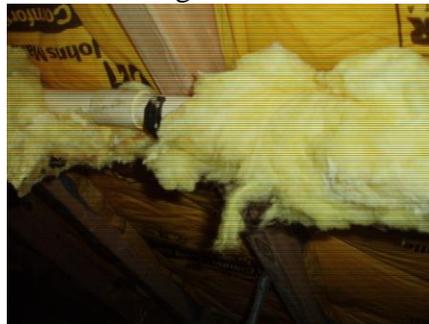
- 5) The cold water main in the crawlspace has a minor leak on a glued joint and repair is required. Recommend the same. The mains shut off valve was not noted and advise from the seller as to its location should be sought.

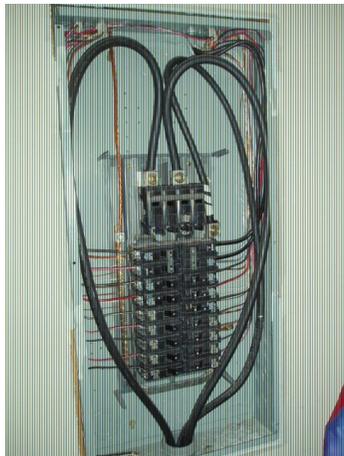
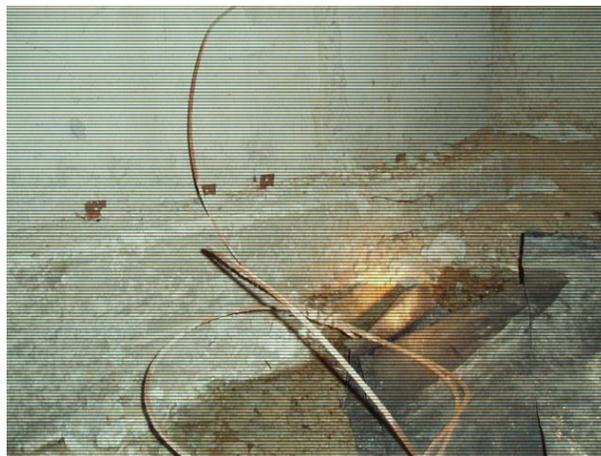
- 6) In the crawlspace a grounding wire was found left un earthed to grounding. This could potentially be the main electrical panel ground wire and therefore needs to be checked/tested by a qualified electrician to substantiate and make safe or remove appropriately. Recommend the same.

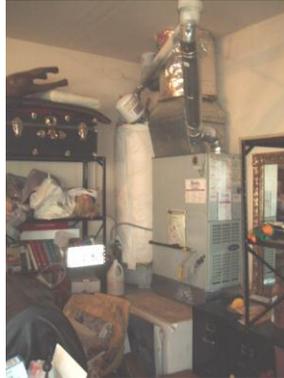
- 7) Access around the crawlspace is not to code and requires cripple stud alterations and ducts undermined to give appropriate access for inspection/repairs. Recommend the same.
- 8) The furnace was run up and seemed to operate appropriately but it is recommended that the system be checked/repaired by a qualified engineer prior to the close of escrow with particular attention to the heat exchanger. The hot water heater was noted to be original and may require replacement at any time.

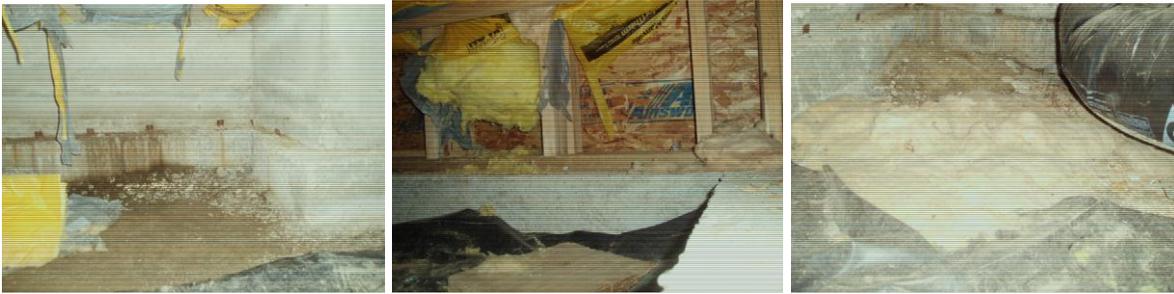
- 9) One exhaust duct has fallen off its roof cap in the attic and needs to be re-attached.
- 10) Some minor ground water entry into the crawlspace was noted near the back door area. Some wood scraps were also noted which should be cleared and some insulation on the floor also. Some areas of bare ground may want additional vapor barrier.
