REPORT NUMBER: ICN9243AR001 : 19090901081

HOME INSPECTION REPORT FOR:

ON: 19th September 2009 - **FEE PAID \$379.00**

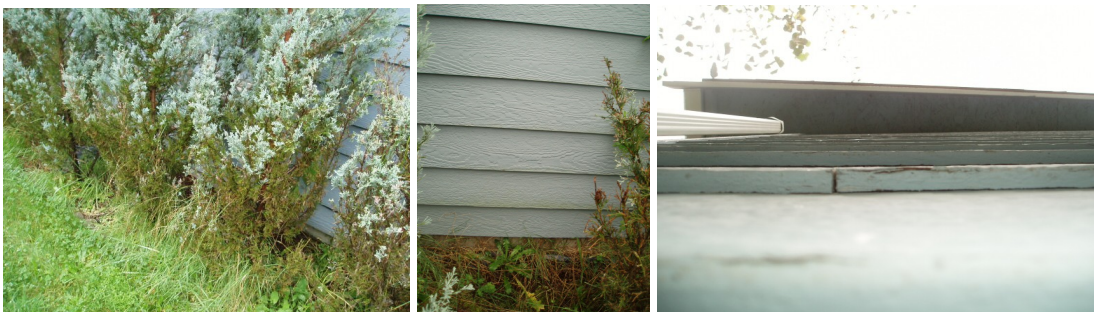
- 1) Vegetation close to the house should be kept back to help keep prolonged moisture off the siding. Where it is close to the gas fire flue vent it is a FIRE HAZARD and must be cleared. Some Verdi Gris on the northern elevation was noted. We assume that the home has not been painted since new and advise from the seller should be sought. Some caulking is starting to fail and exposed edges can be seen. Butt joints are exposed. Drip edges have some minor fraying. Some earth to wood contact needs remedy. Minor damage may be present. Some exposed nails have rusty heads. Recommend appropriate sealing, caulking and painting in due course so as to help prolong the life span of the material.

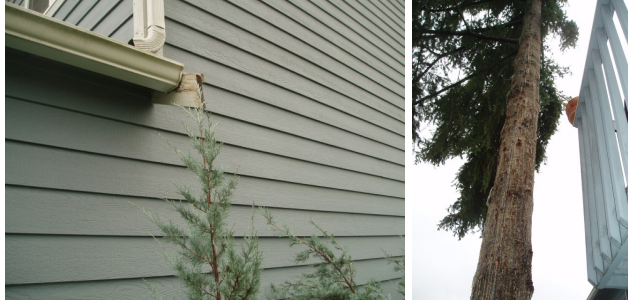
- 4) A tree close to the house may be a cause for concern and obviously drops debris and creates moss on the roof.

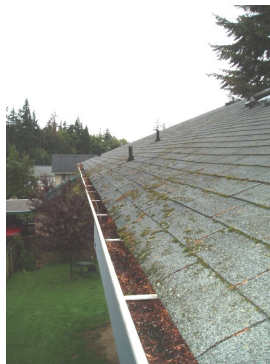
- 6) Gutters need cleaning and should be disconnected from drainage pipes prior to this work to prevent clogging.

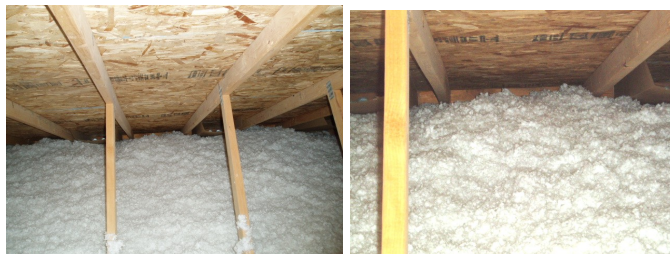
- 7) In the attic the non ventilated rafter bays on the eastern elevation can be seen to have slightly darker roof sheathing in the lower 1-2 feet of the said bays. This may indicate that moisture forms during wet weather and may slowly degenerate the sheathing materials as they get older. Recommend monitoring and if necessary ventilating each bay as appropriate.

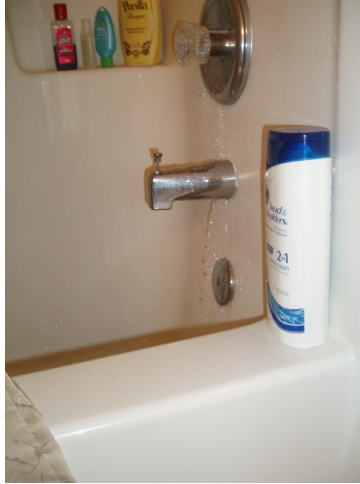
- 8) Some leakage was noted around one shower threaded joint which needs attention but also another tub spout leaked when in the shower mode which needs to be fixed.

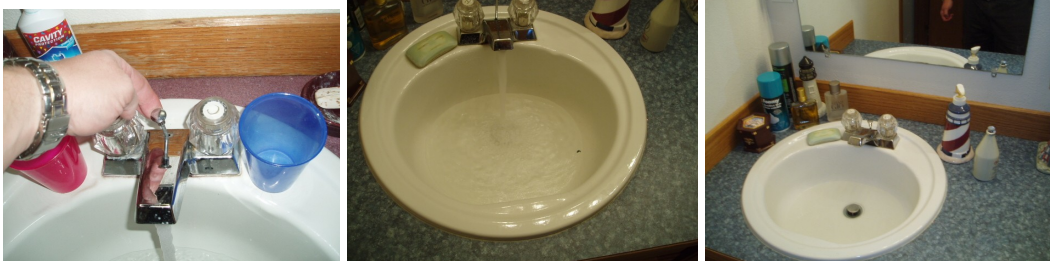
- 9) A vanity sink stopper is not working and two vanity sinks had some slow drainage and some blockage may need remedying. One sink has a minor abrasion of its enamel.

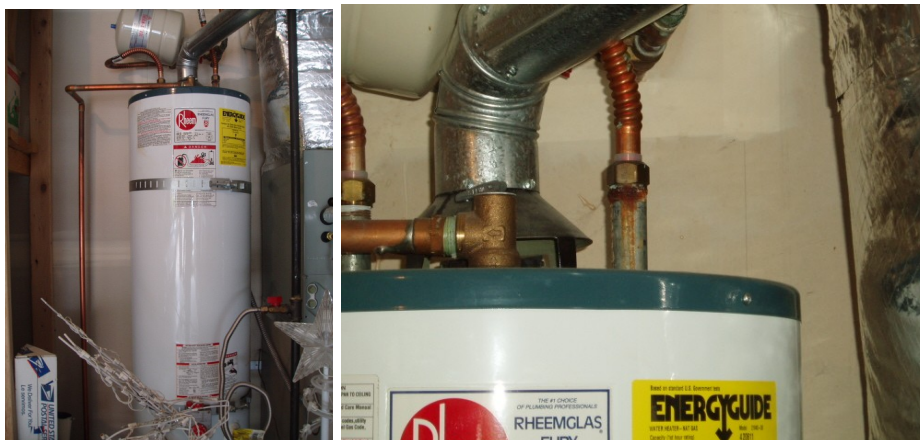
- 10) The hot water heater is gas fired and is now 7 years old and may require repair or replacement at any time. Corrosion around a galvanised nipple was noted and no dialectic fitting is used and repair may be warranted.

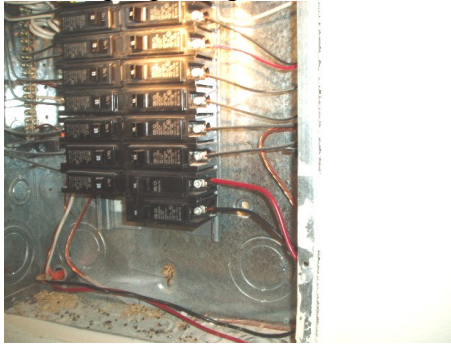
- 11) Arc fault circuit interrupters are fitted for the bedroom circuits and seemed to operate appropriately. Ground fault circuit interrupters on outlets in wet areas also. The main panel did have one loose wire which was tightened under its terminal. It was on a 30 amp breaker and not marked and has been installed since installation and advise from the seller should be sought. Several outlets were checked for their polarity and grounding and proved satisfactory. Recommend checking/repairing all outlets once the home is vacant.

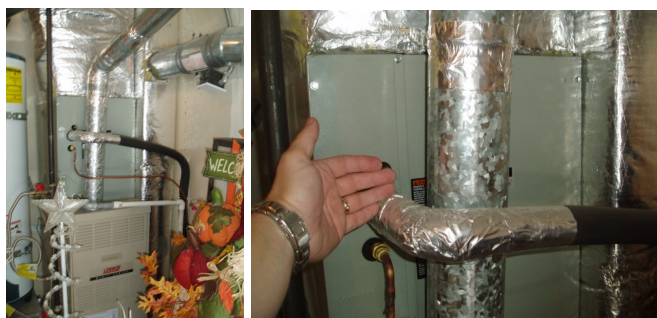
- 13) Cooling and heating were monitored during the inspection and seemed to be operational with appropriate temperature differentials. Recommend that the system be fully evaluated and repaired if necessary by an appropriate HVAC contractor prior to the close of escrow to ensure against any inherent defects especially heat exchanger cracks.

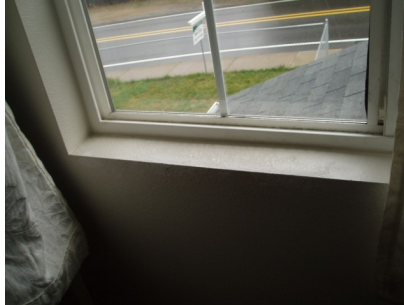
- 15) The windows were noted not to have any wooden sills installed and their finish is poor.

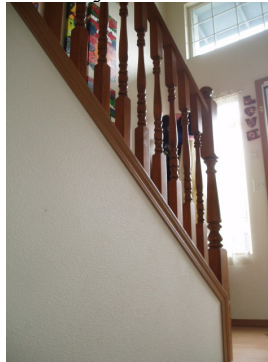
- 16) The staircase main post is a little wobbly/loose and some repair may be warranted.
