**REPORT NUMBER: ICN9243AR13 : 07100901093**

HOME INSPECTION REPORT FOR:

### Summary Report

ON: 7th October 2009 - **FEE PAID \$329.00**

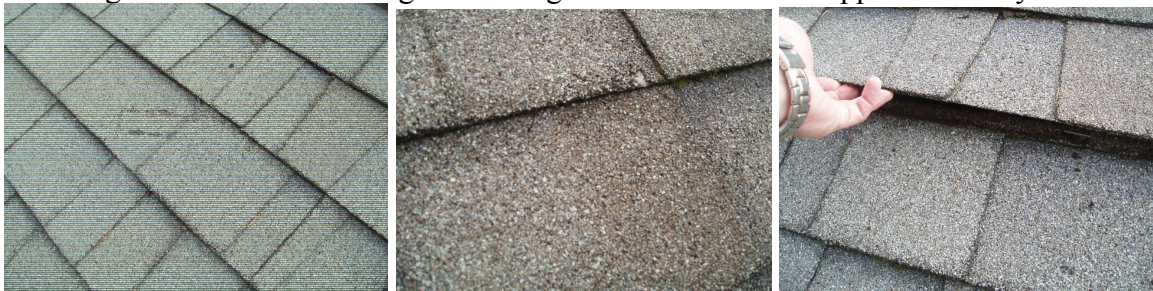
- 1) The roof is a 30 year style architectural asphalt shingle. Unfortunately it as been pressure washed in the past and some minor damage has been caused as can be seen from wand marks in the material piercing through the top layer. This was only found though in a few spots, some bitumastic application may be warranted. Also noted was a few areas of the shingles that have come unglued and again some bitumastic application may be beneficial.

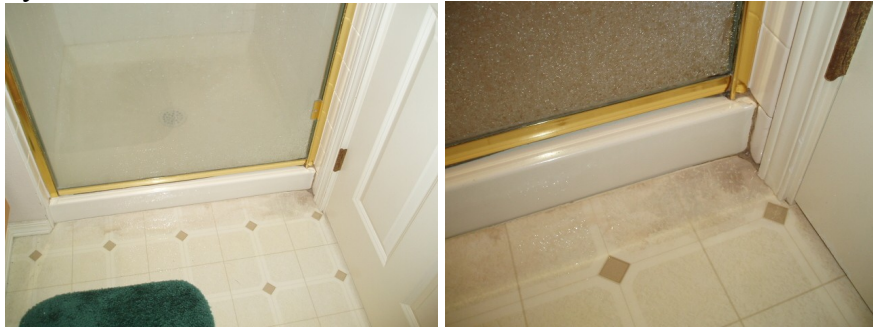
- 3) The hall bathroom shower door/frame has been letting water by and dripping onto the vinyl and into the sub floor and some minor damage is present. Recommend appropriate repairs as necessary.

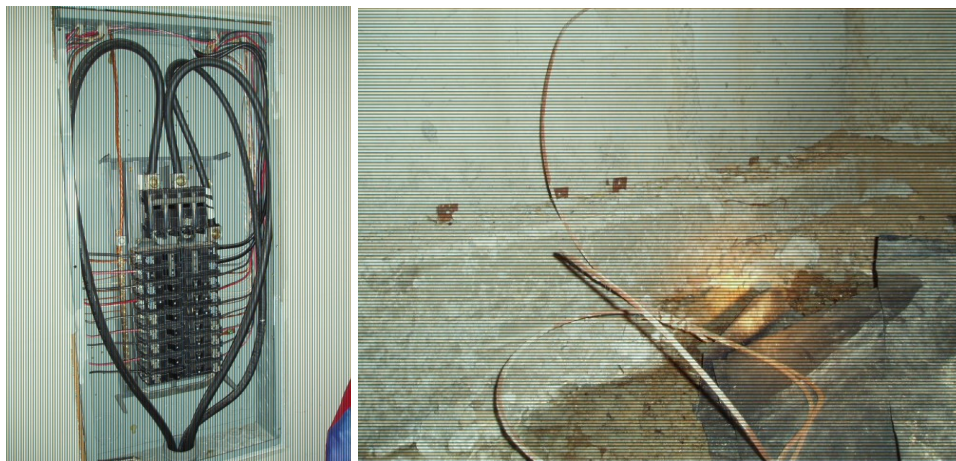
- 6) In the crawlspace grounding wire was found left un earthed to a grounding rod or the like. This could potentially be the main electrical panel ground wire and therefore needs to be checked/tested by a qualified electrician to substantiate and make safe or remove appropriately. Recommend the same.

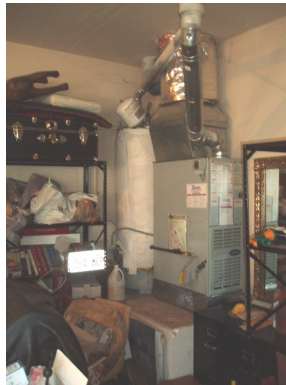
- 7) Access around the crawlspace is not to code and requires cripple stud alterations and ducts undermined to give appropriate access for inspection/repairs. Recommend the same.
- 8) The furnace was run up and seemed to operate appropriately but it is recommended that the system be checked/repaired by a qualified engineer prior to the close of escrow with particular attention to the heat exchanger. The hot water heater was noted to be original and may require replacement at any time.

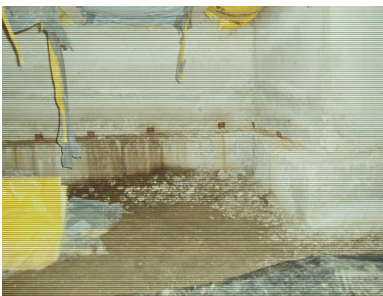
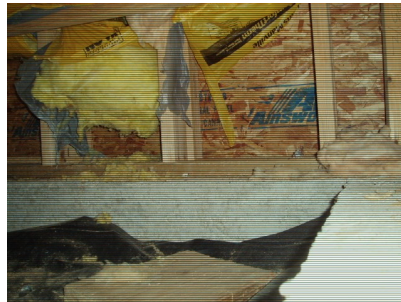
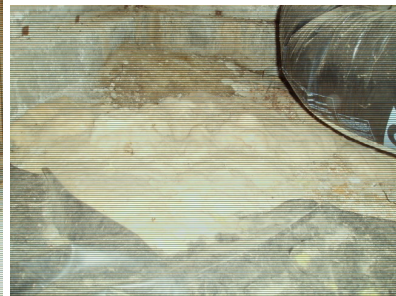
- 9) One exhaust duct has fallen off its roof cap in the attic and needs to be re-attached.
- 10) Some minor ground water entry into the crawlspace was noted near the back door area. Some wood scraps were also noted which should be cleared. Some insulation on the floor also. Some areas of bare ground may want additional vapour barrier.
